WETLAND RESTORATION PLAN

Williston Village RV Resort
Section 24, T155N, R101W
Williams County, North Dakota
Project #4554

Williston Village RV Resort Wetland Restoration Plan
Section 24, T155N, R101W
Williams County, North Dakota

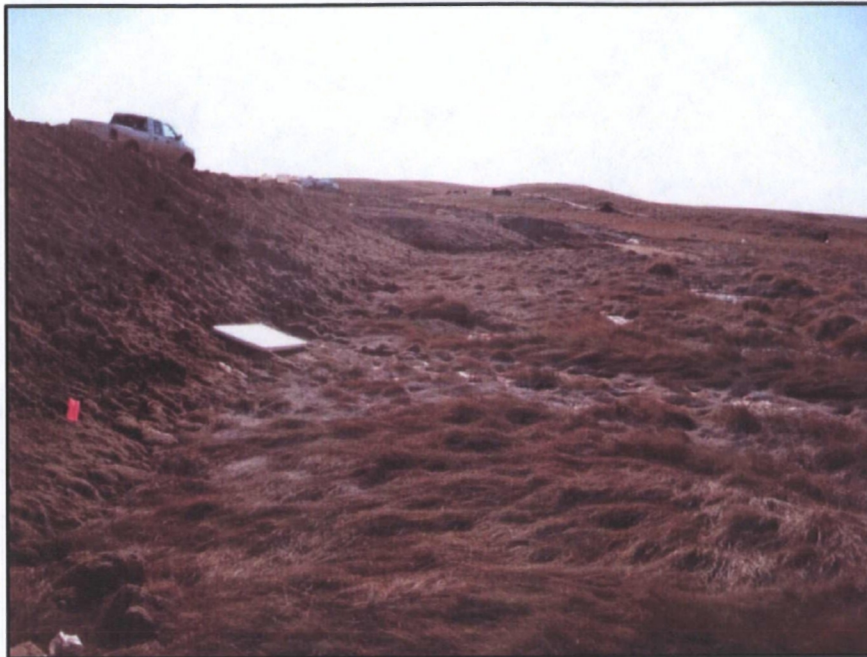
Photograph 1. View of the fill materials located within the downstream portion of the impacted wetland area.

Approximately 148,000 cubic yards of fill materials were inadvertently placed in the wetland area. Approximately 30,000 cubic yards of upland vegetated topsoil was placed on the original wetland surface and 118,000 cubic yards of clean fill was placed on the topsoil fill materials. The clean fill materials were identified as sandy lean clay glacial till and/or sandy coarse alluvium.

The vegetated topsoil fill materials consist of Williams-Zahl loams, (surficial clayey sand) which were placed on the original wetland surface. Clean fill materials were placed on top of the vegetated topsoil fill material.

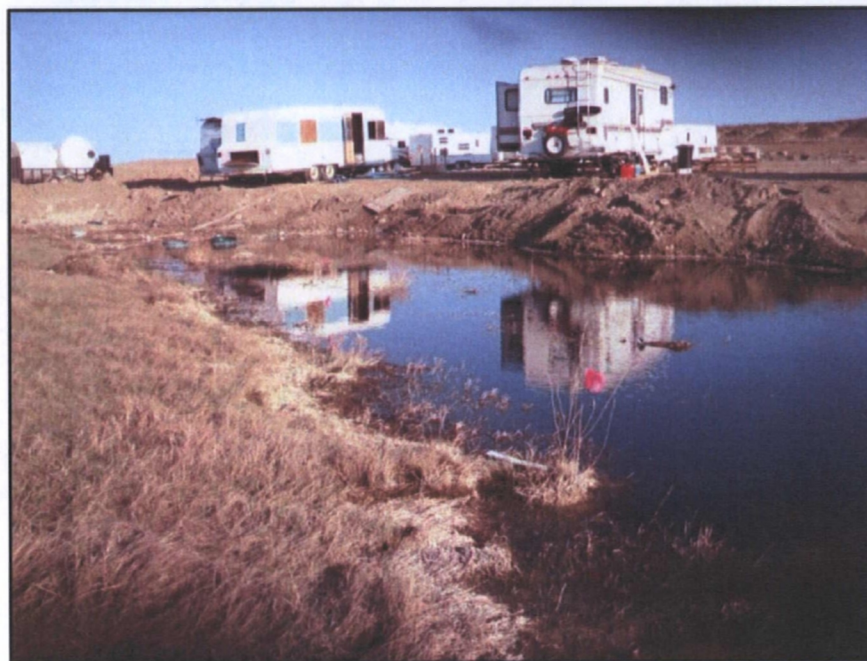
Photograph 2. View of upstream edge of the impacted wetland area. Surface water accumulated in the upstream portion due to the fill materials.

The impacted wetland had a seasonal hydrologic regime. Its hydrology was influenced by surface water flow and by groundwater (approximate 9 inches in depth as varies seasonally from 0-18 inches in depth) flow through the site. The impacted wetland contains Harriet soils and was vegetated with saline tolerant species. Alkali grass (*Puccinellia nuttalliana*), saltgrass (*Distichlis spicata*), and foxtail barley (*Hordeum jubatum*) are prevalent along the edge of the impacted wetland area. The uplands surrounding the impacted wetland area consist of Williams-Zahl loams which contain an average depth of groundwater to be greater than 80 inches. The depth of groundwater in the area has been estimated to be near an elevation of 1880 feet above sea level and this is consistent with the surface of the impacted wetland area.

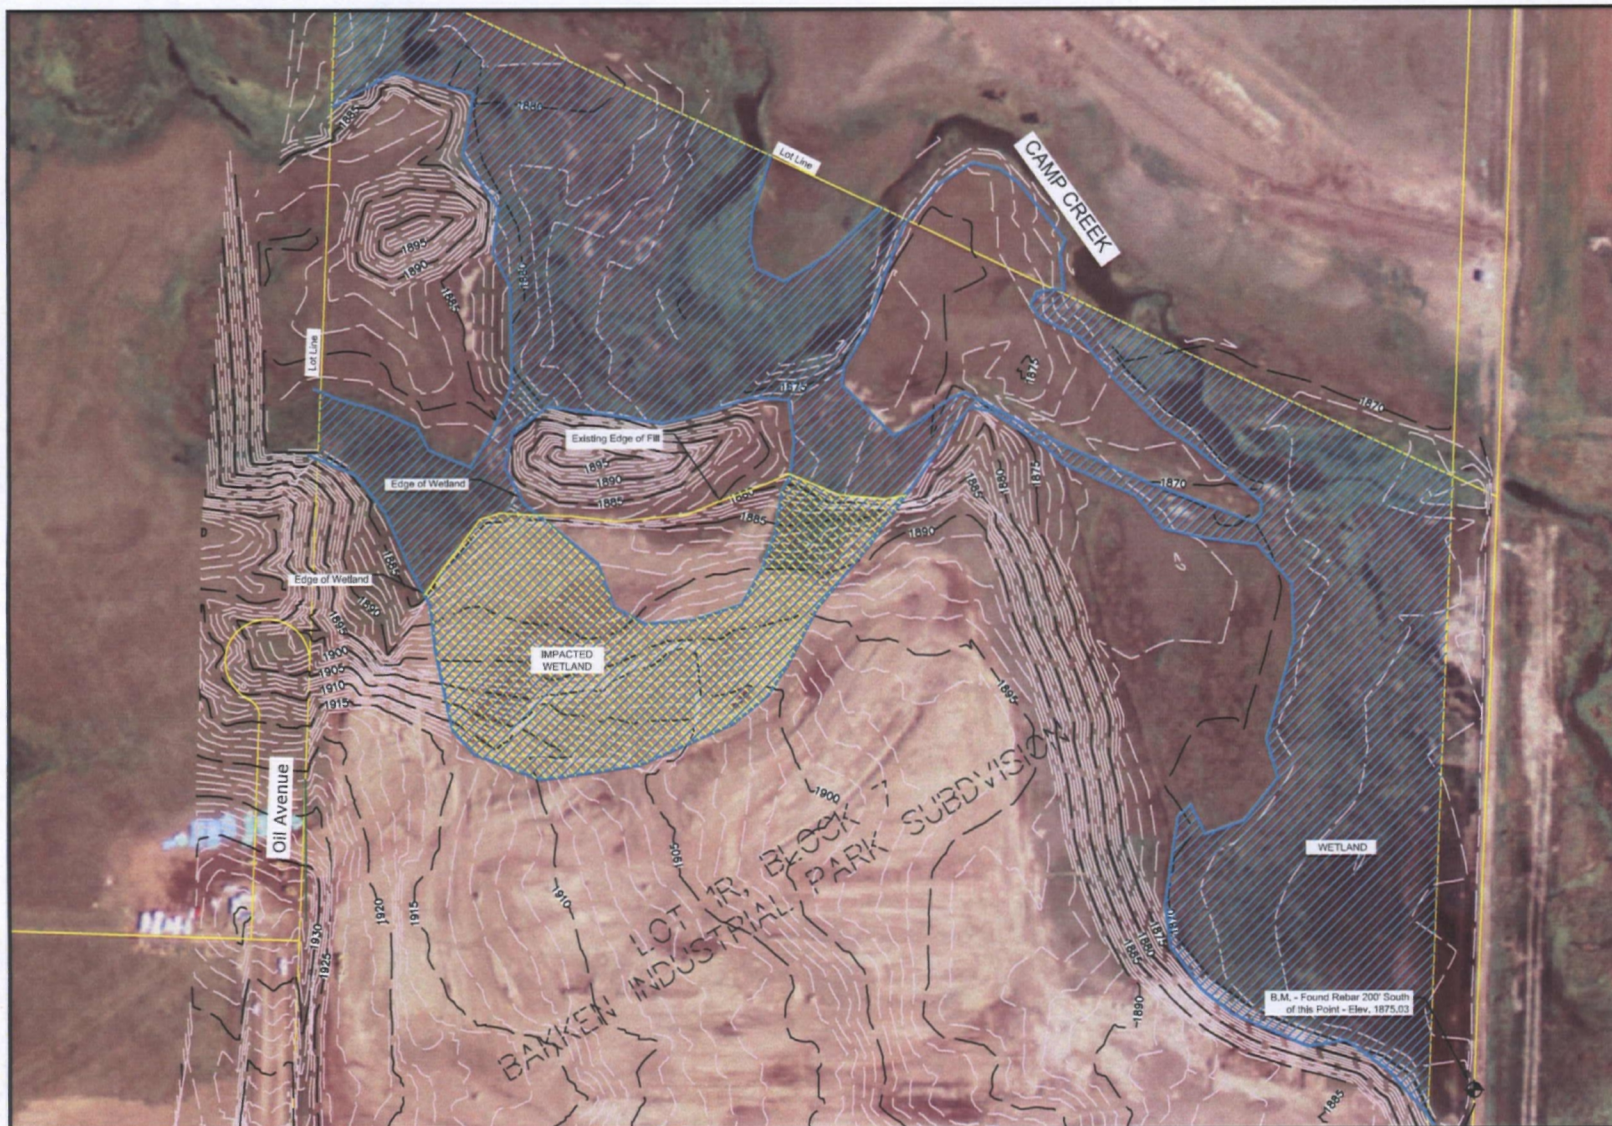
2
 of
 5

**WETLAND RESTORATION
 OVERALL VIEW**

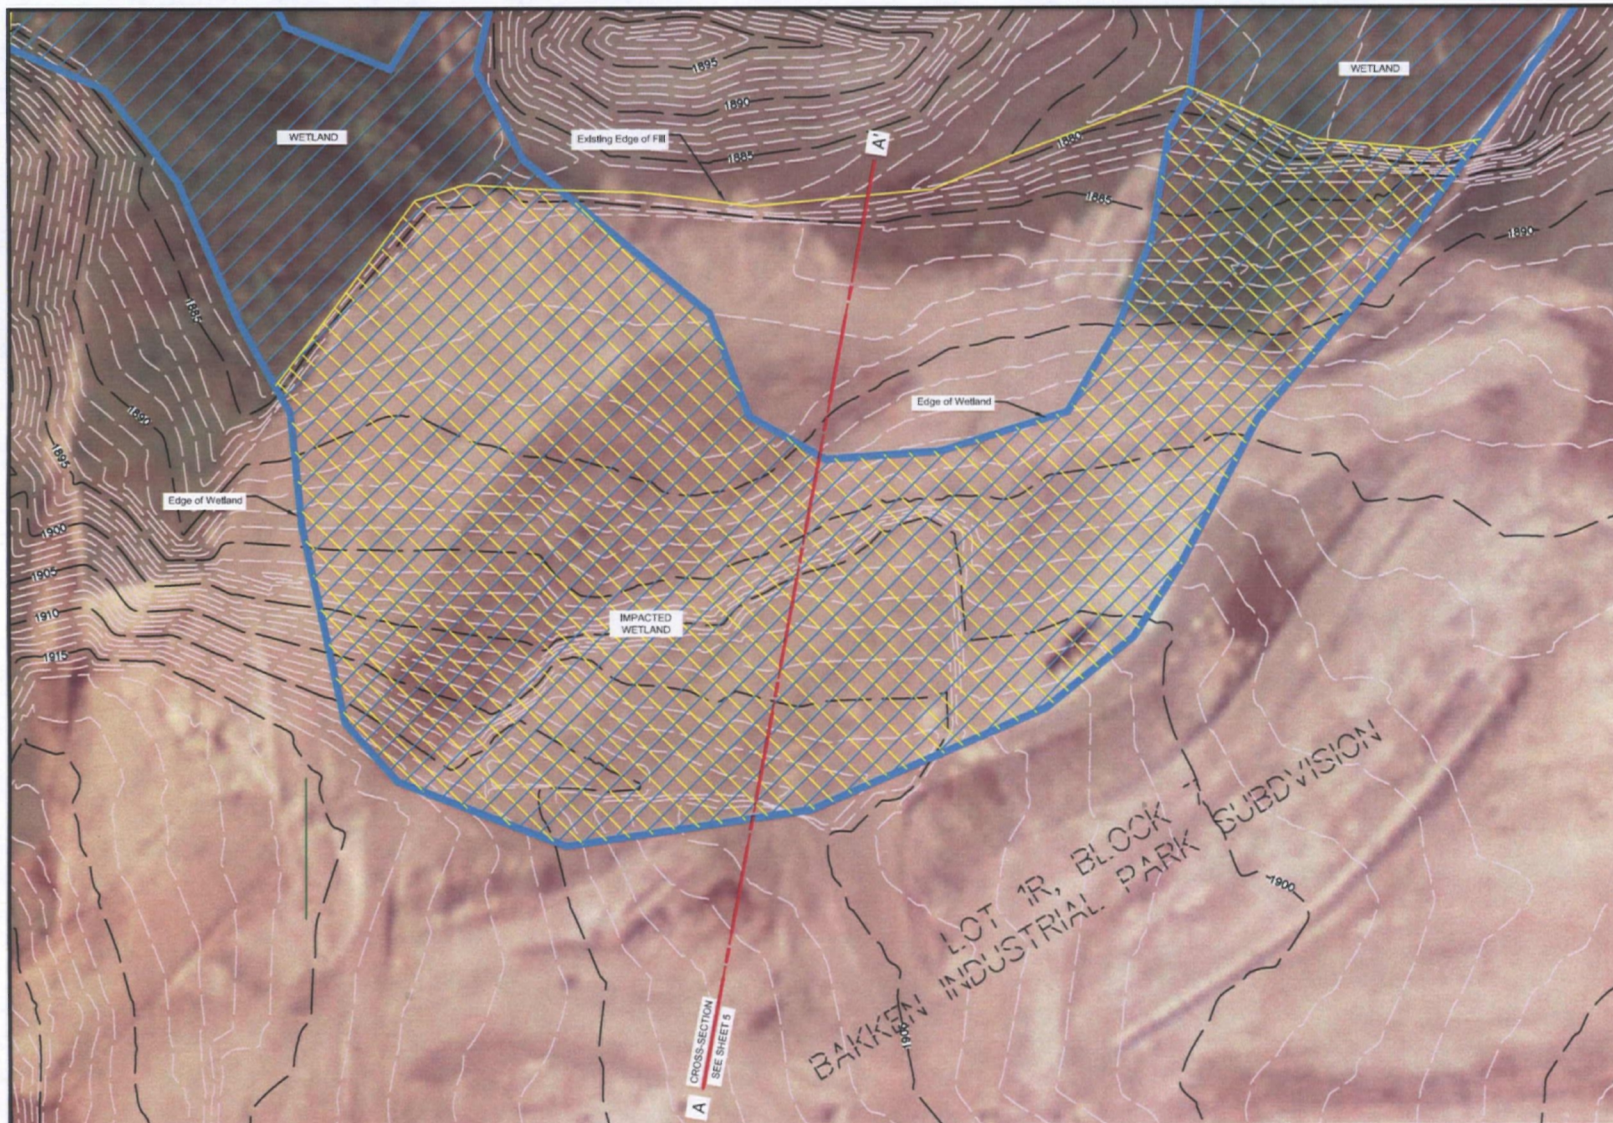
3
of
5

**WETLAND RESTORATION
EXISTING CONDITIONS**

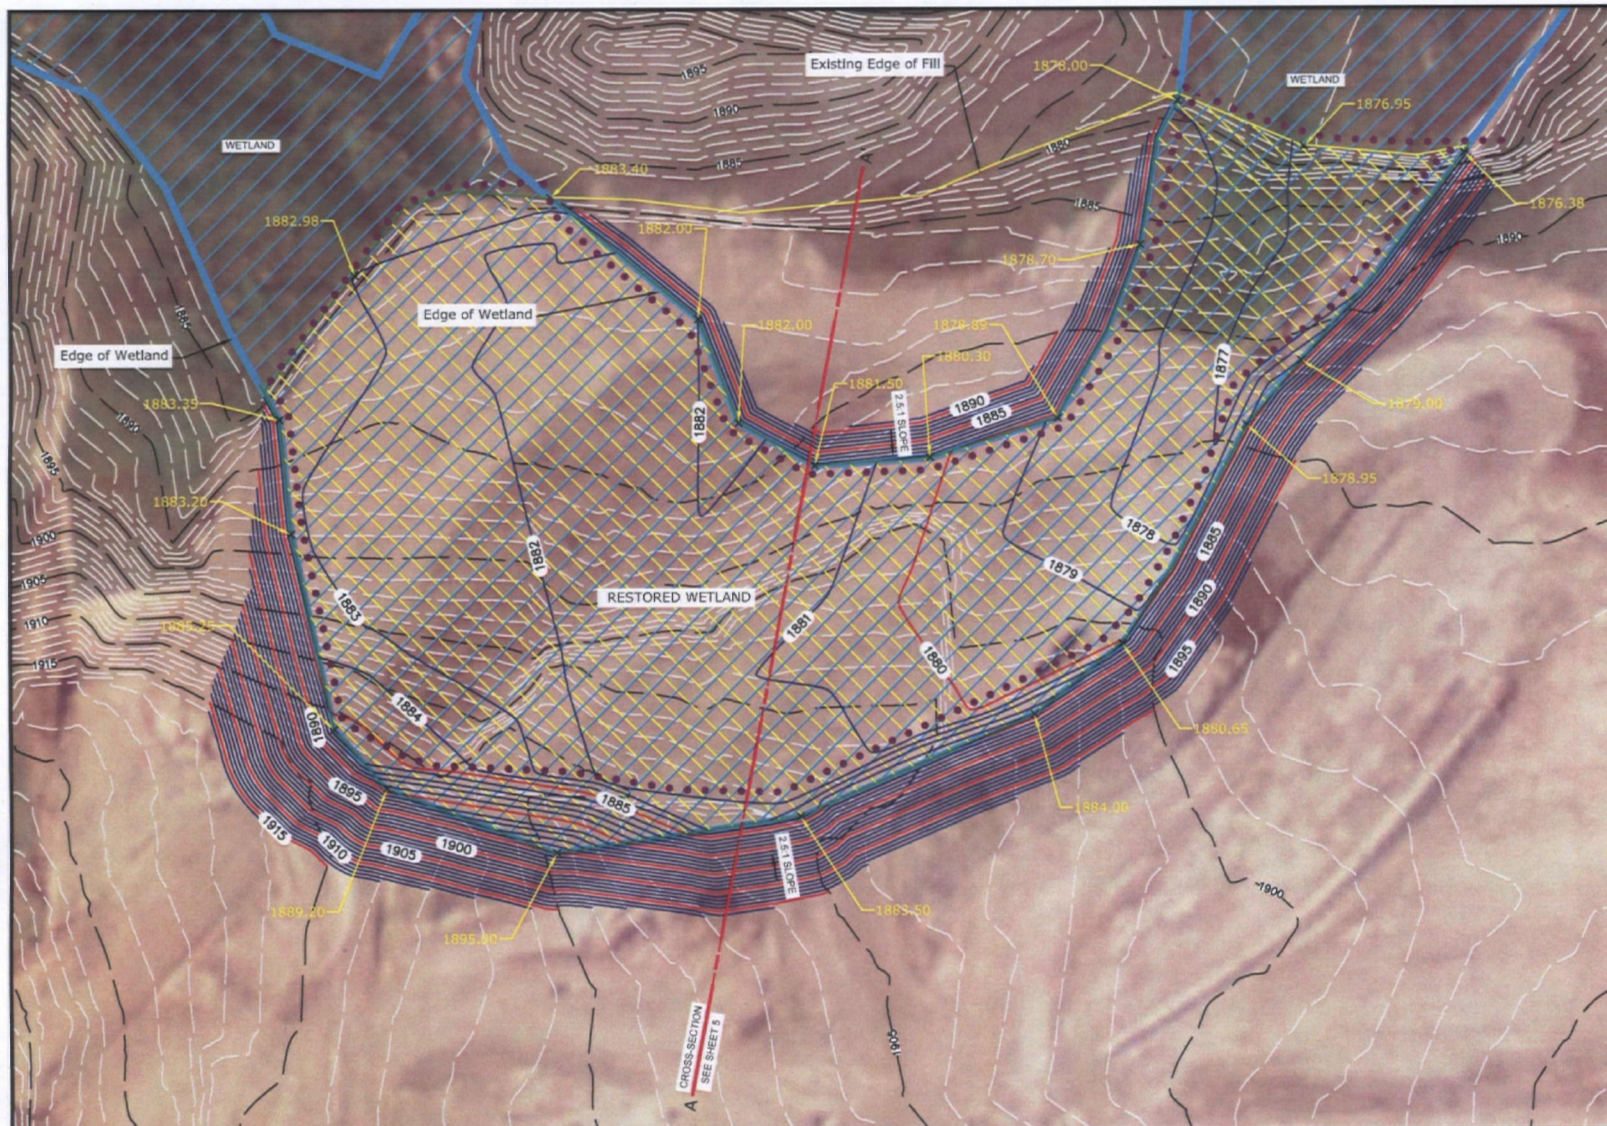
- LEGEND**
- 1869 CONTOUR (EXISTING)
 - WETLAND
 - RESTORED WETLAND
 - 1870 CONSTRUCTED CONTOUR
 - PROPOSED SILT FENCE

Restoration activities will include removal of fill materials to the original elevations of the impacted wetland surface. The original surface elevations range from 1882.98 (upstream edge) to 1876.95 (downstream edge). Prior to impact, water flowed east through the wetland towards Camp Creek.

Approximately 148,000 cubic yards of material will be removed to restore the impacted wetland to its original ground surface. Conventional excavation equipment (dozers, scrapers, backhoes) will be used to remove fill materials. The use of conventional excavation equipment will ensure the restoration is completed quickly which will allow the restored site to quickly resume wetland functions. The excavation equipment will access the impacted wetland area from the south across upland areas. Excavated fill materials will be placed on the surrounding upland areas to the south and east of the impacted wetland area (Appendix A).

The boundaries of the fill area will be staked by surveyors to limit impacts to adjacent wetland areas. Grade elevations of the depth of fill to be removed will be staked on a 100 foot grid across the area of fill. Surveys and staking of grade elevation of the depth of fill will be conducted routinely to insure that all fill materials are removed and over-excavation of the impacted wetland area does not occur.

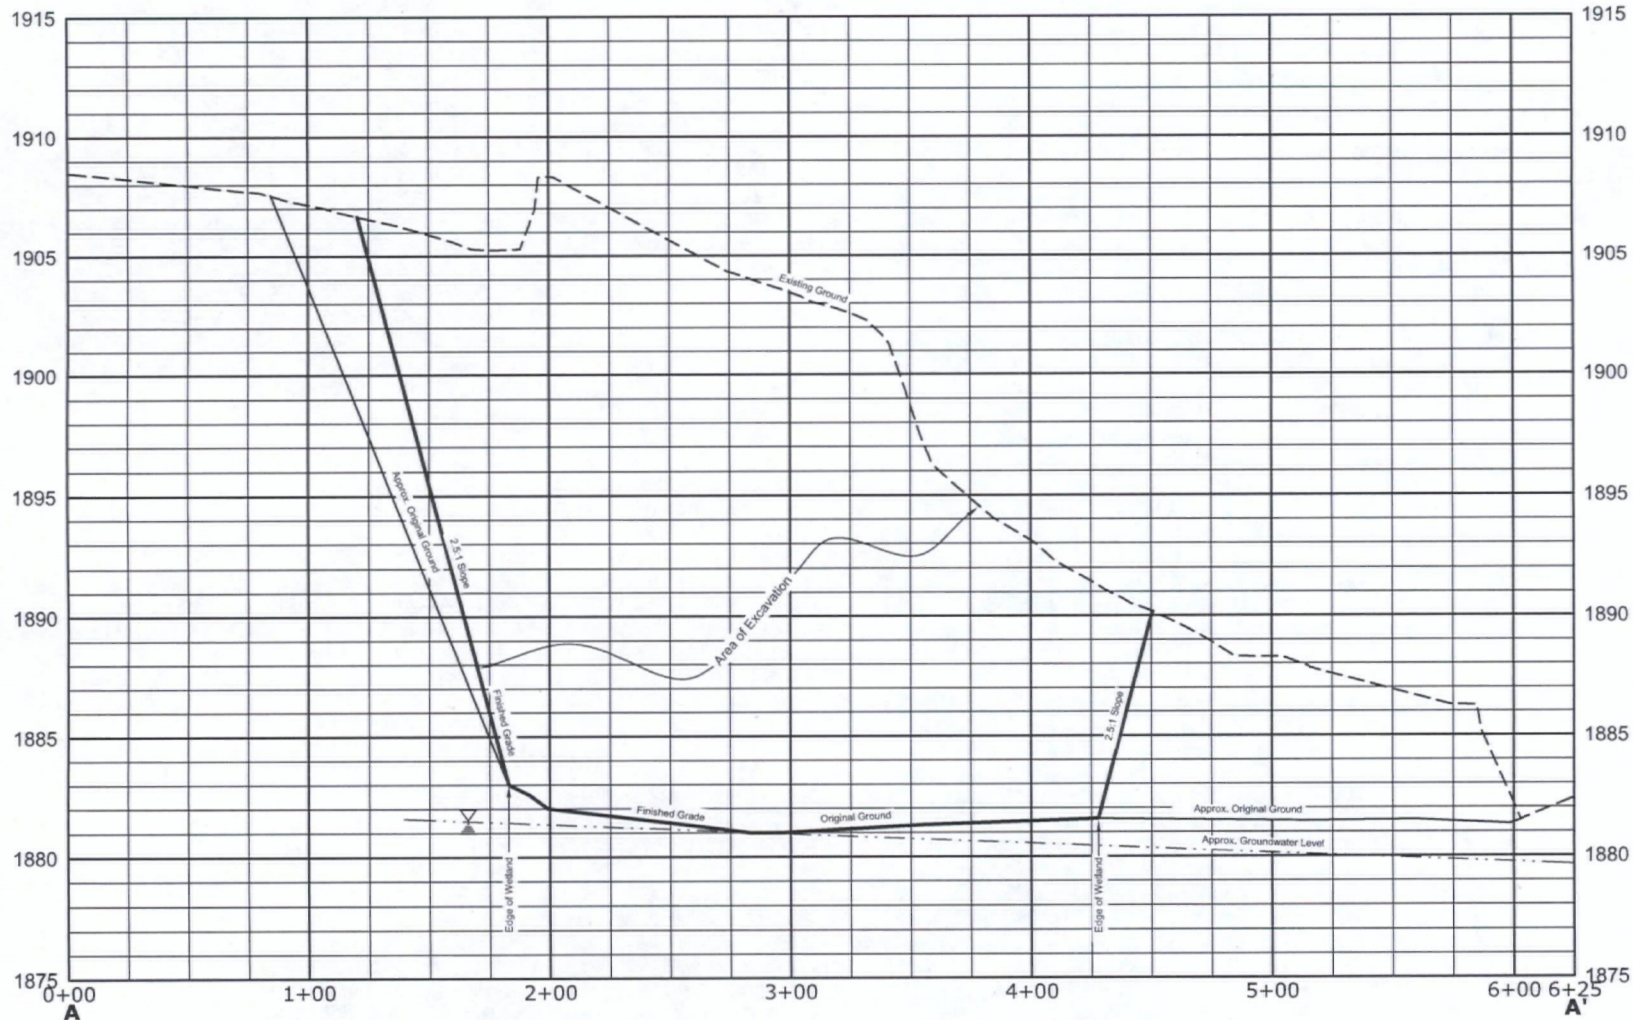
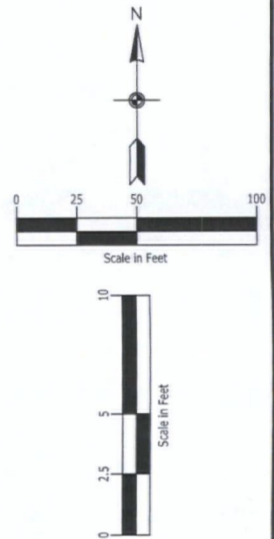
5
of
5

CROSS-SECTION A-A'

**WETLAND RESTORATION
CROSS-SECTION A-A'**

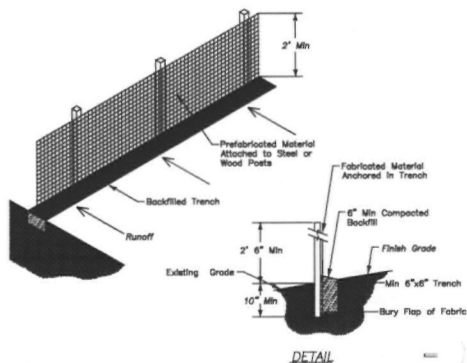
DETAIL

1. Silt fence shall be installed before any earth removal or excavation takes place.
2. Set posts maximum 8 feet on center and excavate 6"x6" trench upslope along the line of posts.
3. Attach filter fabric to posts and extend it into trench.
4. Backfill and compact excavated soil.

SILT FENCE INSTALLATION

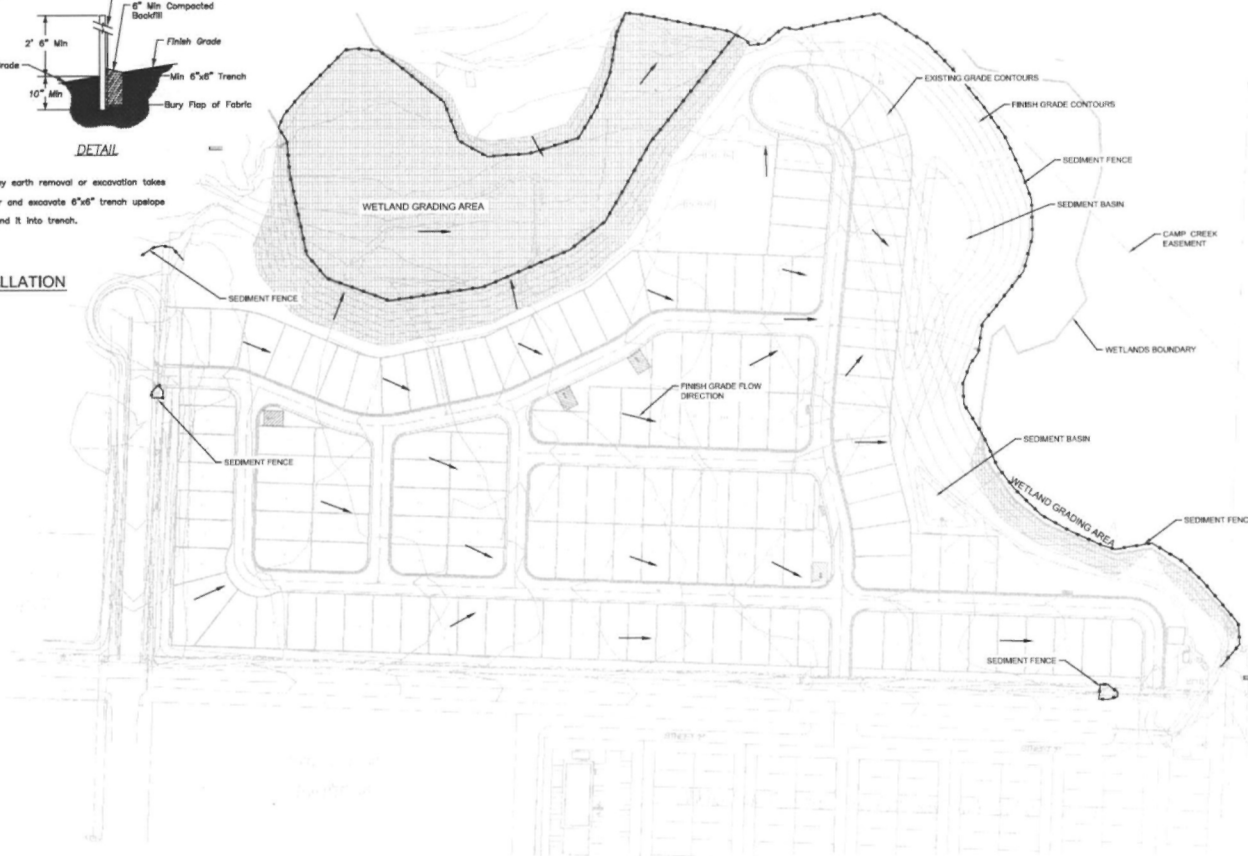
SHEET
 1 of 1

SILT FENCE - 4,360 LF

WILLISTON VILLAGE MOBILE HOME PARK
 STORM WATER PROTECTION PLAN (SWPP)

Best management practices will be implemented by the contractor while removing fill materials from the impacted wetland area. Storm Water Pollution Prevention Plan (SWPP) measures will be implemented to limit impacts to adjacent wetlands (Appendix B). Additional measures will include the use of construction mats or low ground pressure equipment if the site becomes saturated or as the excavation approaches final grade to reduce compaction of the impacted wetland area. Silt fences placed along the upstream and downstream wetland edge will be removed following the excavation of the fill materials. Additional silt fences will be placed at the base of the graded slopes following the removal of the fill materials to keep sediment from the graded slopes from eroding into the wetland. These silt fences will be left in place for a minimum of three years or until the graded slopes are stable and vegetated.
